CASE STUDY

CONNECTICUT DEPARTMENT OF TRANSPORTATION WATERBURY BRANCH RAILROAD CULVERT RELINING NAUGATUCK, CT

**Project No. 300-102
Bridge No. 08280R
Waterbury Branch**

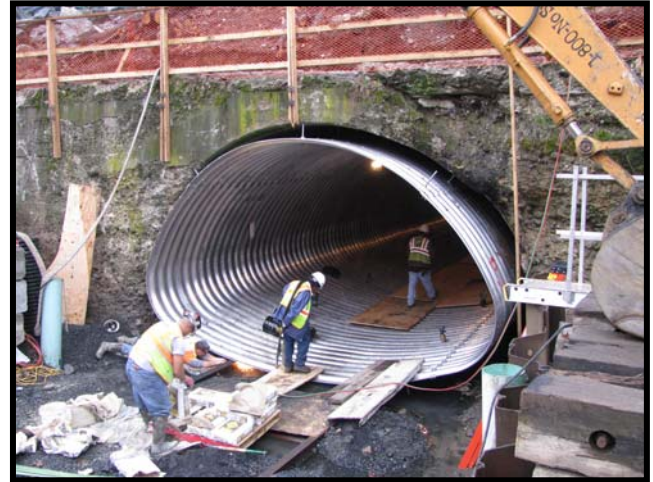
Rebuilding America's infrastructure is the charge for today's municipal stewards. The infrastructure boom of the early 20th century is being followed by the reconstruction and rehabilitation boom of the early 21st century. Much has changed over the past 100 years, but the necessity for these critical components has not. In fact, the necessity drives the most notable challenge – maintaining functionality during reconstruction. This challenge is best illustrated by a recent rehabilitation of a Waterbury Branch RR culvert crossing in Naugatuck, CT, where CTDOT was tasked with the rehabilitation of severely corroded twin concrete arches.

The existing concrete arches each had a 20-ft span and an open (i.e. natural) bottom. An 18'-5" x 11'-6" aluminum structural plate pipe arch shape was chosen for the reline material. The south culvert required 109-ft of relining, while the north culvert required 111-ft.

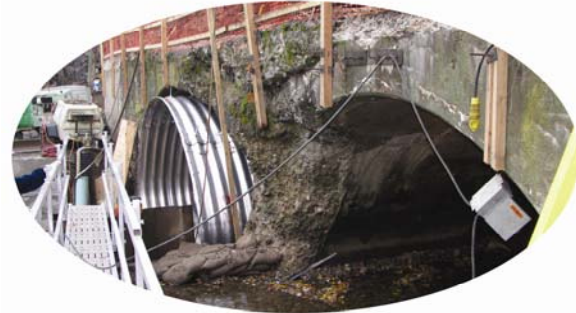
Structural plate is shipped to the site in curved plates and field assembled into its final shape by bolting. Lane Fabricators (a division of Lane) provides assembly when needed, but in this case the contractor had no qualms in completing the assembly.

With flow bypassed into the north culvert and a cofferdam constructed around the south culvert outfall, the south culvert was completely lined with structural plate in one day. A reversal of this arrangement facilitated the installation of the north culvert in a similar fashion.

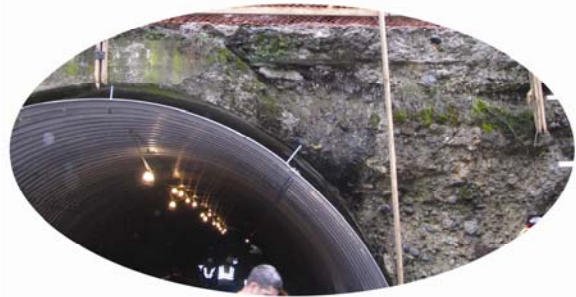
Once the structural plate is assembled and the bolts are tightened, the pipe arch is precisely positioned with the use of alignment bolts. Alignment bolts around the periphery and along the entire length of the relining plate ensure the shape is properly situated within the host structure.

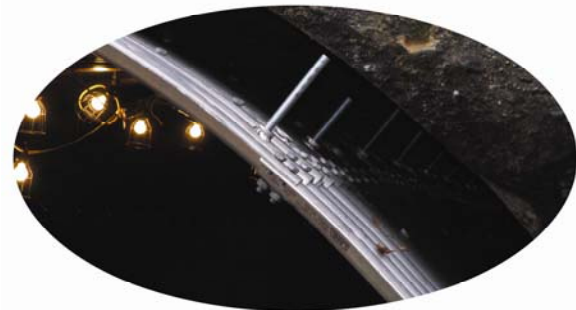
After the pipe arch has been completely aligned into its final position, preparations can be made to grout the annular space. The relining plate includes a number of grout plugs around the circumference and along the length to facilitate this process.

Due to the buoyant forces generated as the annular space is filled, additional bracing may be necessary to help counteract any associated movement. The grouting is typically staged into multiple lifts to lesson any flotation effects, with adequate setting time allowed between each pour.

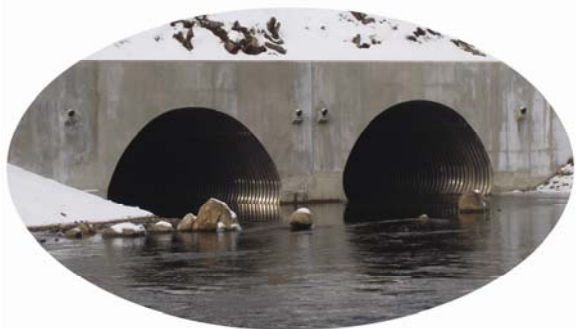
The project included the complete rehabilitation of the concrete headwall. This final touch brought the appearance of the culvert restoration to a “like new” condition. From beginning to end the restoration project was accomplished in two months.
